# DETECTION OF DAMAGED PROPS AND THEIR POTENTIAL IMPACT ON STRUCTURAL STABILITY DURING CONSTRUCTION

## Abstract

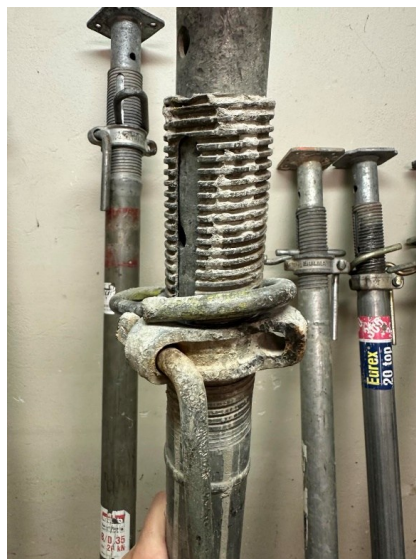
The prop exhibited significant physical wear and tear on its contact surfaces, along with noticeable deformations, which prevented it from standing independently and caused it to rotate during fixation (see Fig. 2). The threaded rod was heavily contaminated with concrete or cement residue, obstructing the smooth rotation of the thread around its axis. When tightened manually, the prop could not be fixed between floor slabs, as human force alone was insufficient to overcome the contamination in the thread. The thread was not lubricated, making its movement difficult and prone to jamming. Additionally, the thread had defects, such as a bent thread rail, which prevented the crank handle from passing through. The technical condition of the prop was classified as unsatisfactory, making it unsuitable for use on the construction sites. It was recommended to decommission this prop.

Fig. 2 Broken thread on the support.

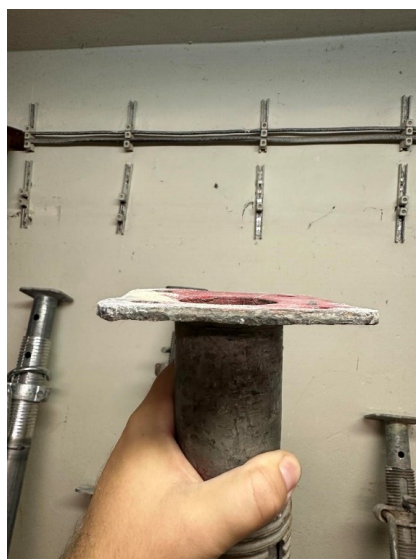
The MUBA props exhibited deformations on the contact surface edges at both the top and bottom steel plates (see Fig. 3). Similar to the previous prop, this deformation caused the prop to rotate during fixation and resulted in an uneven distribution of pressure on the floor slab. At the top section, near the joint between the tube and the top plate, minor defects were present, including cracks near the welds. The thread was cleaned; however, the upper section had deformed thread rails. The technical condition can be classified as moderately severe, and it was recommended the prop to undergo technical adjustments or be decommissioned.

Fig. 3 Bent steel plate.
