THE IMPACT OF ELEVATED TEMPERATURES ON THE INTERACTION OF FRP REINFORCEMENT AND CONCRETE: AN EXPERIMENTAL STUDY

Juraj Lagin^{*1}, Martin Zlámal¹, Đorđe Čairović¹, Pavlína Zlámalová¹, David Vašátko¹, Petr Štěpánek¹

Abstract

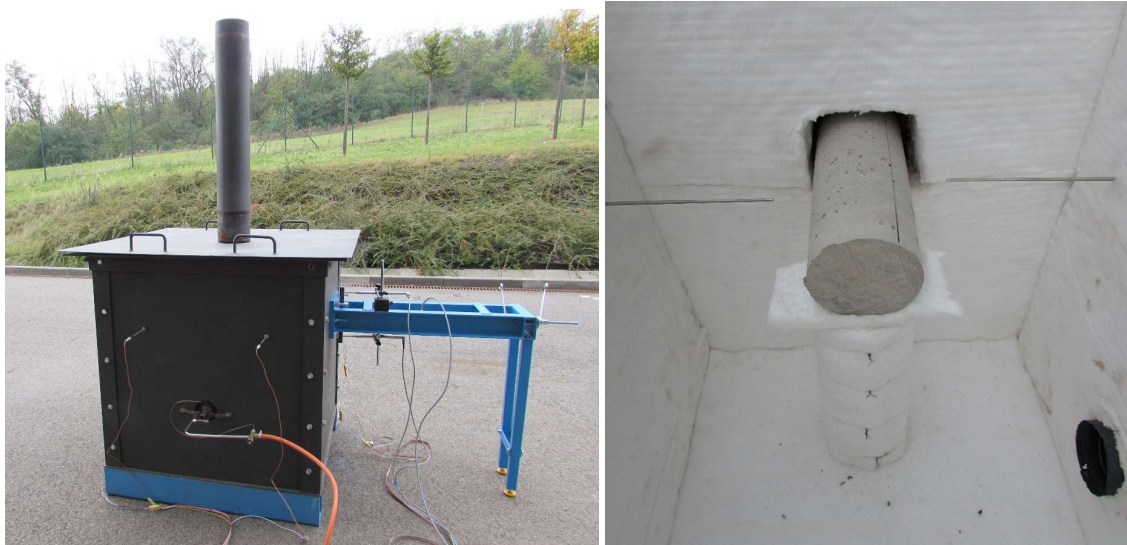
In the case of specimens loaded with elevated temperature, the concrete block of the sample is placed horizontally into the heating furnace (see Fig. 4 left) at normal temperature. Subsequently, after applying a static force to the rebar, the fire test process begins, defined according to the standard curve ISO 834-1 [11]. Force measurement is ensured by a force meter connected through steel end cap and a joint. In this configuration,

deformation is measured only at the loaded end of the rebar. Fig. 4 on the right shows a sample placed into the heating furnace.

Fig. 4 Test setup for reinforcement fire conditions.

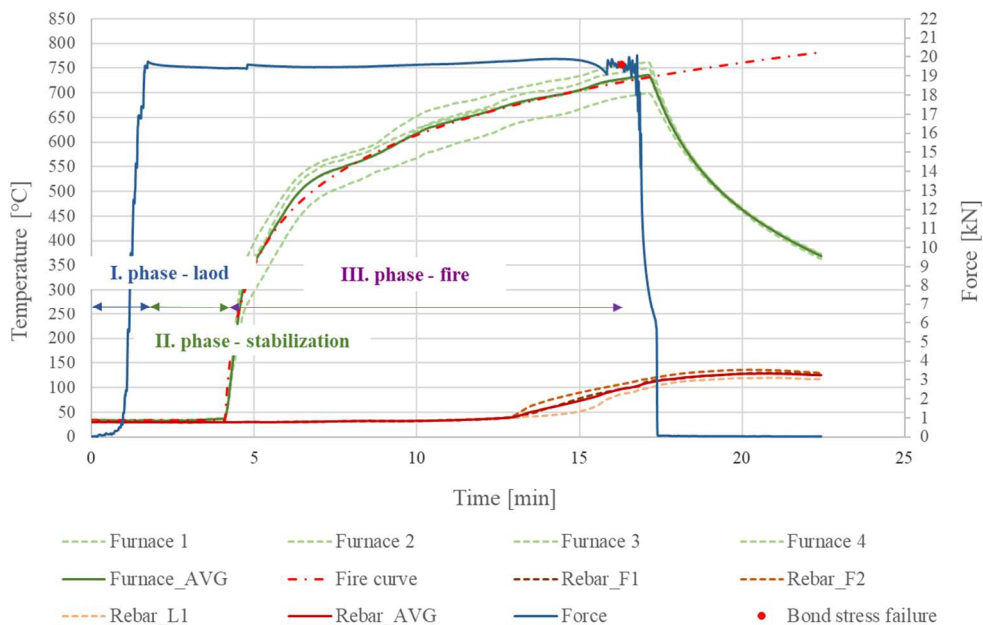
In Fig. 5, it is possible to observe the illustrative progress of the loading test of specimens exposed to elevated temperature. The graph shows the application of static force (blue color), the gradual increase of ambient temperature in the furnace measured by 4 thermocouples (green color, labeled as Furnace 1 to Furnace 4), and the increase of temperature on the surface of the rebar (brown color), measured using thermocouples placed as a pair of opposing thermocouples at the unloaded end (labeled as Rebar_F1 and Rebar_F2) and one individual thermocouple at the loaded end of rebar (labeled as Rebar_L1). The red mark indicates the moment of failure of bond stress of the rebar and concrete. The testing methodology is described in detail in study [10].

Fig. 5 Illustrative progress of the loading test of samples exposed to elevated temperature [10].

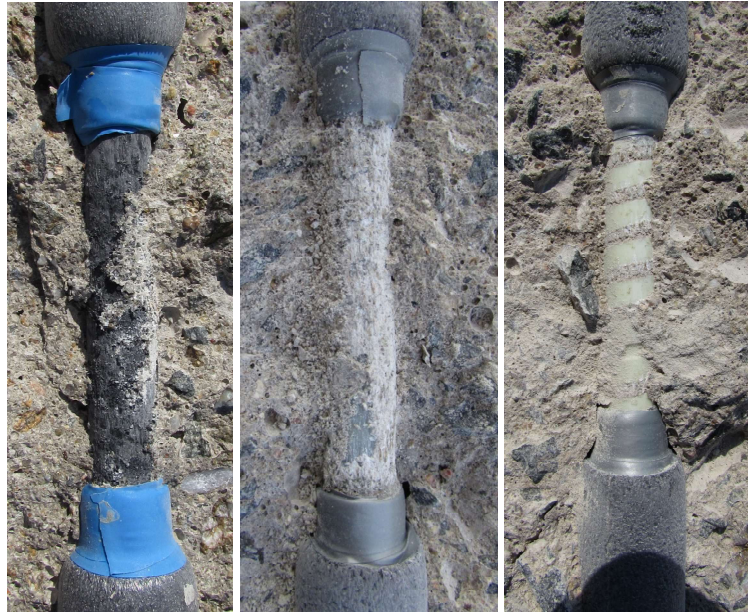
Fig. 8 Typical failure of the reinforcement in pull-out tests under normal conditions a) RockBar "BN", b) ReBar "PN", c) ComBAR "CN" (left to right).

Surface modification of FRP reinforcement by sand coating seems to be more suitable in terms of bond stress of concrete at normal temperature. Considering the differences in the quality of concrete in individual series, i.e. approximately 15% lower tensile strength of concrete for samples with ComBar reinforcement compared to samples with sand coated rebars ReBar (Fig. 8 a) and RockBar (Fig. 8 b)), the comparison of the test results from the graph in Fig. 6 shows a significantly better bond stress capacity value of sand coated rebars with concrete compared to ComBar rebars which is modified with milled grooves and the bond is mainly provided by the anchor effect between the rebar and the concrete. In this case, the failure is accompanied by the shearing of concrete at the location of the ribs (Fig. 8 c)).
