ASSESSING ADAPTATION MEASURES IN A SELECTED 4TH ORDER WATERSHED

The aim of this study is to propose and evaluate adaptation measures within the selected 4th order watershed (4-15-03-104). The primary goal of these proposed measures is to stabilize the water regime in the landscape and manage extreme hydrological phenomena, as well as to mitigate erosion risks in the territory. This approach aims to create a harmonious landscape aligning with the fundamental principles of sustainable development. Prior to the proposal, the territory underwent a detailed analysis based on available data and field reconnaissance. The research compares two variants with the current state of the landscape. Variant 1 utilizes historical maps as a foundation, while variant 2 incorporates measures designed to optimize the landscape in response to ongoing climate change.

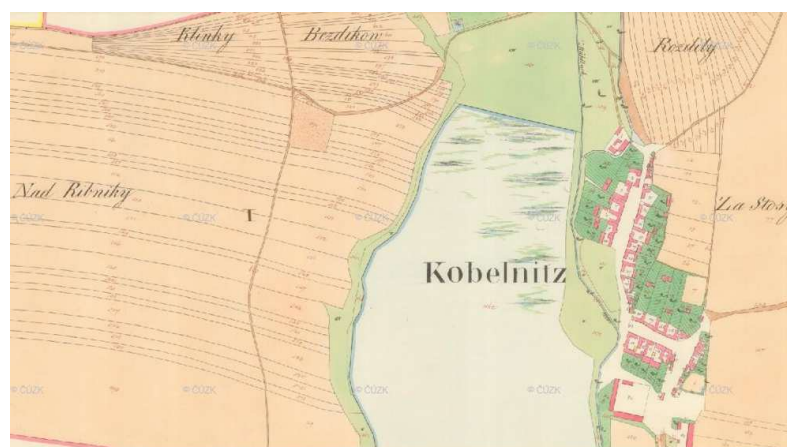
Fig. 2 Historical map from the year 1825.

As part of the study of historical background data [6], the former pond and historical mills become the most interesting from the point of view of the water regime of the area. The historic pond used to exist in the village of Kobelnitz in the local part characteristically called "The Pond", as shown in the Fig. 2. The last recorded mention of this pond is on (several) maps from 1825. On more recent maps, we already find drainage ditches running all over this area. Until now, one of them has remained here and was registered as the main drainage facility.

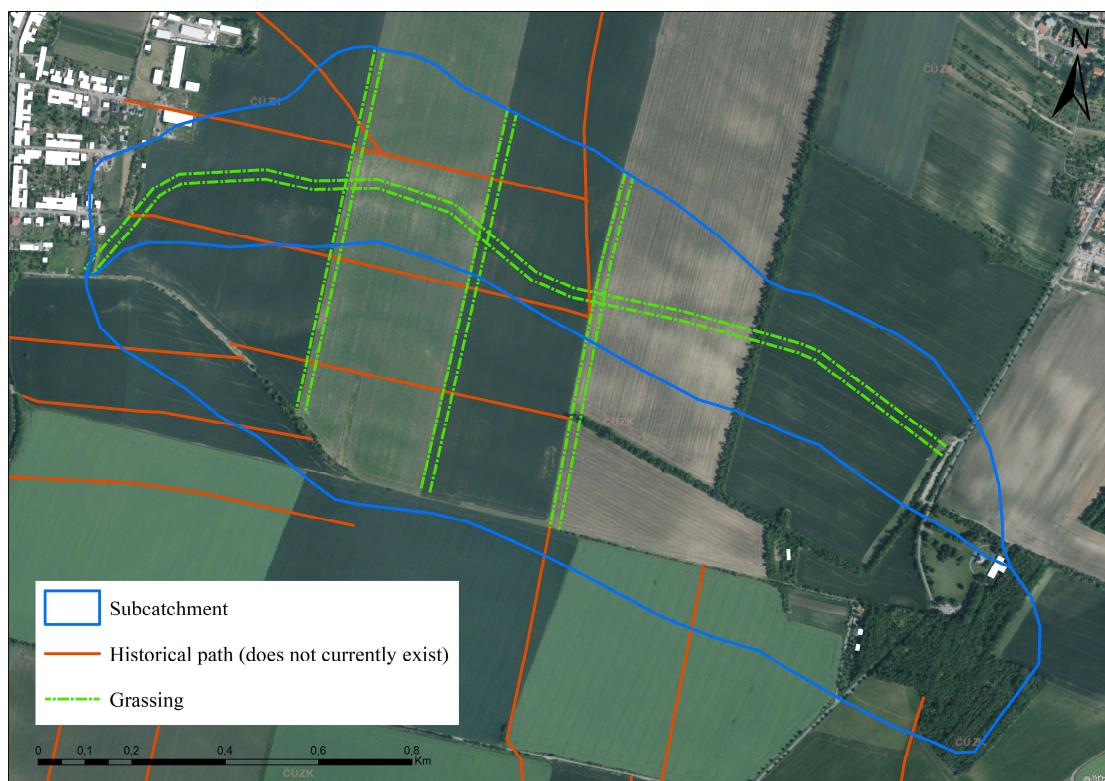
Fig. 9 Variants of measures (var. 0: current state, var. 1: just considered historical paths, var. 2: grassing of thalweg and three grassing strips).

From the point of view of the proposed measures, the N-year maximum flow and wave volume were also compared within the sub-basins. Three variants were compared. Variant 0 as current state, variant 1, when historical roads were considered into the territory, and variant 2, where three grassy strips and stabilization of the path of the concentrated runoff by grassing were inserted into the existing use of the landscape (Fig. 9). We assume that no significant changes have occurred in the terrain, as there are no visible embankments of railways, roads, or highways. Because of this, we see changes in the roughness of the monolith slopes and a change in the CN number (Tab. 2).

In terms of flows, we can see an improvement of up to 23% (flows of 50- and 100-year water) in variant 1, where only the protective grassing of the path of the concentrated runoff and the creation of three protective belts were chosen. In variant 1, the highest improvement was at Q₅₀ flows, with a 10.5% reduction in flows. In terms of flood wave volumes, we also see the greatest improvement in option 2 (approx. 18% at Q₁₀₀), when option 1 reduced the flood wave volume at Q₁₀₀ by 5.5%. See Tab. 3 for exact data.
