# PRESTRESSED TRUSS GIRDER AFTER 60 YEARS

## Abstract

Many concrete roof structures built in the past century are dealing with corrosion of the prestressing reinforcement. This has been the cause of several failures of prestressed roof girders in the Czech Republic and Slovakia. This article focuses on prestressed truss roof girders. We will discuss various types that were constructed in former Czechoslovakia and abroad during the past century.

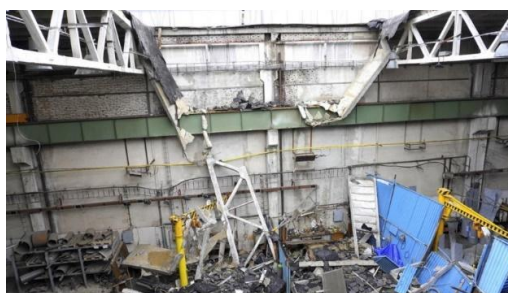
Fig. 2 Truss girder collapse in the Czech Republic from 2023 [4].

In 2010, 2018, 2023 (see Fig. 2), and 2024, five collapses of prestressed truss girders happened in the Czech Republic and Slovakia [4]. From the time of former Czechoslovakia, at least one case of collapse of this type of structure is known (see Fig. 3) [5]. The primary cause of these collapses was the corrosion of the prestressing reinforcement. Following discussions between ČKAIT (Czech Chamber of Chartered Engineers and Technicians) and the Ministry for Regional Development, a regulation was issued requiring owners of buildings with these structures to have them professionally inspected [6]. According to [4], an estimated 10,000 of these truss girders are located in the Czech Republic.

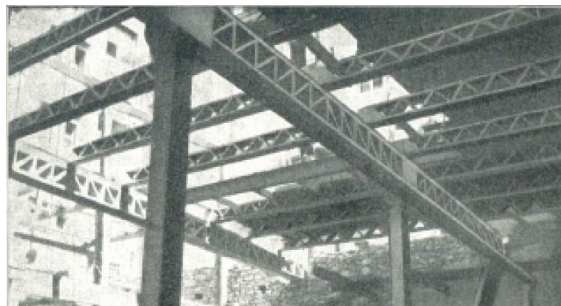
Fig. 6 First concrete truss girders at the beginning of the 20th century [14].

The first concrete truss girders began to appear at the beginning of the 20th century (Fig. 6). These were girders for railway bridges, which were also used for roofs and floors of buildings [14]. The first use of prestressed truss girders dates to the 1930s in Germany fig. 7 [15].

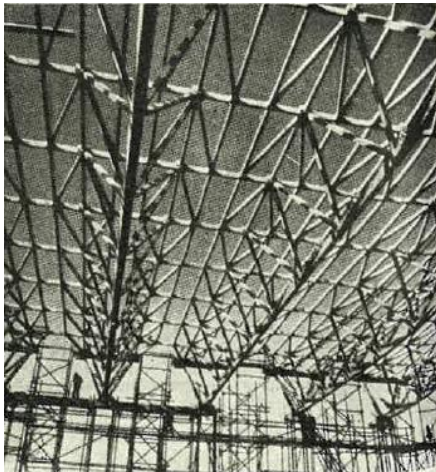
Fig. 13 View of the roof structure under construction at the Gatwick hangar [21].

An interesting roof structure was built in Gatwick, south of London. It is a roof for an aircraft hangar (see Fig. 13) with a length of 86 meters, a width of 36 meters, and a total height of 12.5 meters. The hall is surrounded by an extension on three sides. The supporting structure of roof is designed as a spatial truss frame made of prestressed concrete. The individual trusses, placed every 6 meters, are 2.6 meters high and have a span of 32 meters. The truss consists of an upper chord, which has 6 bars, each 1 meter long, and a lower chord made of 1 bar (see Fig. 14). Every second and fifth bar of the upper chord is connected to the lower chord by a diagonal brace. In the plane of the upper chord, the bars are indirectly connected by diagonal braces, which ensure rigidity in the transverse direction. The assembly of the trusses was performed on the ground beneath their final placement location. The individual elements were connected using prestressing and then lifted into their final position on temporary scaffolding. Once all the trusses were in place, the structure was prestressed in the transverse direction (concrete and Constructional Engineering no. 8/1958. Civil Engineering and Public Work's Review July/1958) [21].

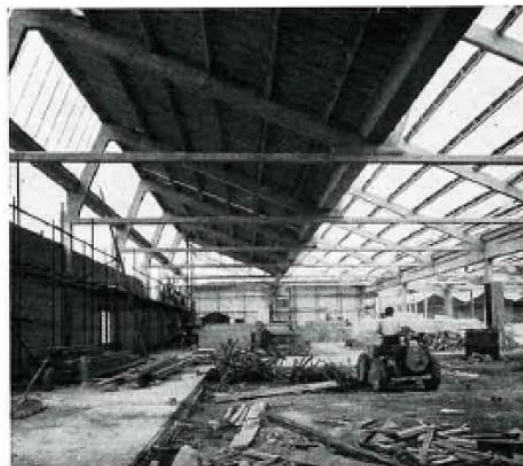
Fig. 17 View of the under-construction roof of the Bristol Workshop Building [13].

In Bristol, England, a workshop building was constructed for the company Wilhelm. The roof consisted of two triangular prefabricated trusses and two prefabricated rods (see Fig. 17). These elements were then assembled on-site. The trusses are designed for a span of 18 meters and a center-to-center distance of 6 meters. The purlins are designed in an L-shape, and the roofing is made of asbestos-cement corrugated sheets [13].

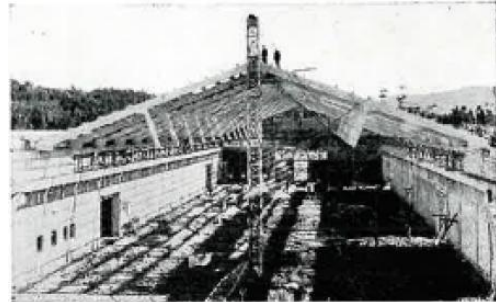
Fig. 19 View of the expanded roof of the Hall in Avilés [13].

An interesting solution for truss girders appeared in Spain, where the tensioned elements were designed as exposed reinforcement. Triangular trusses with exposed lower reinforcement, for spans of 20 to 30 meters (see Fig. 18), were developed by Prof. Dr. C. Fernandez Casado. This method was used for the Endasa company hall in Avilés, with a span of 30.7 meters (see Fig. 19). The roof covering is made of corrugated asbestos-cement sheets [13].
