INDOOR MICROCLIMATE OF A PRESERVED MOUNTAIN VILLAGE DWELLING IN THE ORE MOUNTAINS: A CASE STUDY

Abstract

Preserved village dwellings provide a satisfactory indoor microclimate when an appropriate building use regime is applied. Using eight dataloggers, we monitored the indoor environment in a case study of a mountain dwelling built in 1911 in Bublava, located in the Ore Mountains, over one week during the summer and autumn. The results show that this case study house, largely preserved in its original state of construction, has an effective use regime and is highly adaptable to different weather conditions.

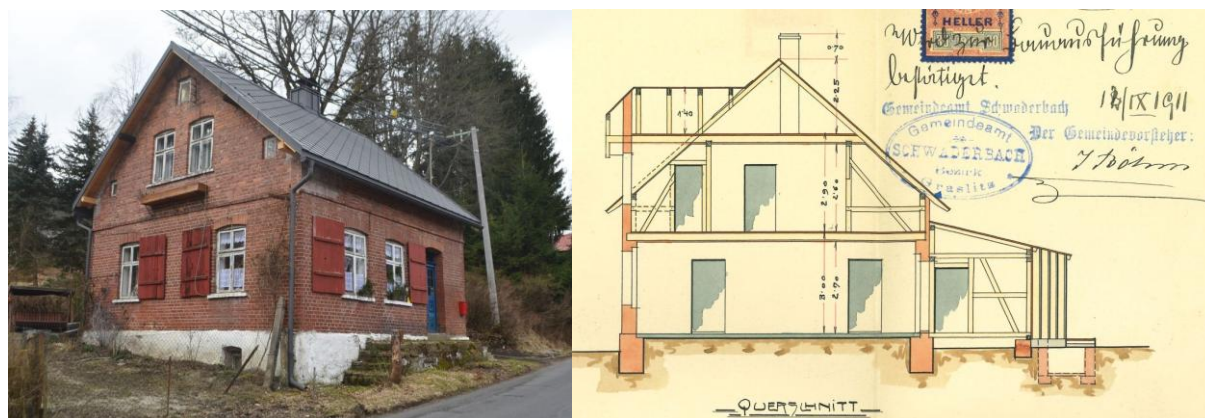
Fig. 1 The view of the case study building in 2024 from the south-east (left). The section of the case study house on the original building plan (right). The house was originally designed without basement and with a dormer which remained unrealised [14].

Case study house description

The case study house, built in 1911 for Gustav Seifert and designed by master builder Emanuel Gemeinhardt from Kraslice, serves as a family residence [14], (Fig. 1). It is a two-story house with a basement under approximately one-third of a ground plan.

The foundations consist of stones laid with clay mortar. The load-bearing structure is made of exposed masonry of German format using clinker bricks. The ceiling between the first and second floor is timbered with a plastered reed underlay. The ceiling between the basement and the ground floor consists of three fields of brick vaults supported by steel beams. The floor in the living room and the kitchen is made of wide wooden planks nailed to the support beams laid on the ground. In the hallway on the ground floor, there is a floor made of cement tiles laid directly on the ground. The floor on the second floor consists of planks nailed directly to the ceiling beams. The staircase to the upper floor is made of solid wooden boards. The roof is supported by a truss with purlins in the middle of the span of rafters. The roofing is partially reconstructed and consists of wooden planks covered by modern waterproofing foil covered with modern aluminium shingles. The living rooms on the second floor are separated from the remaining attic space by masonry partitions located under the purlins, and by a ceiling at the level of the purlins. The ceiling consists of wooden beams covered with wooden planks underneath with a reed underlay and lime plaster. Apart from the roofing, the constructions are original from the time of construction of the building in 1911. The doors are original wooden framed doors with a wooden panel or glass

The original design of the bedroom (B), separated from the attic by partitions and a ceiling, creates an insulating air volume in the attic (Fig. 1). During summer, the temperature in the bedroom (B) did not exceed 26.8 °C, despite outdoor temperatures reaching a maximum of 31.8 °C (Tab.1). Adjacent unoccupied spaces, such as the attic (G) with a maximum temperature of 37.1 °C recorded, and the storage room under the roof (E) with a maximum of 29.9 °C recorded, contribute to preventing the bedroom from overheating.

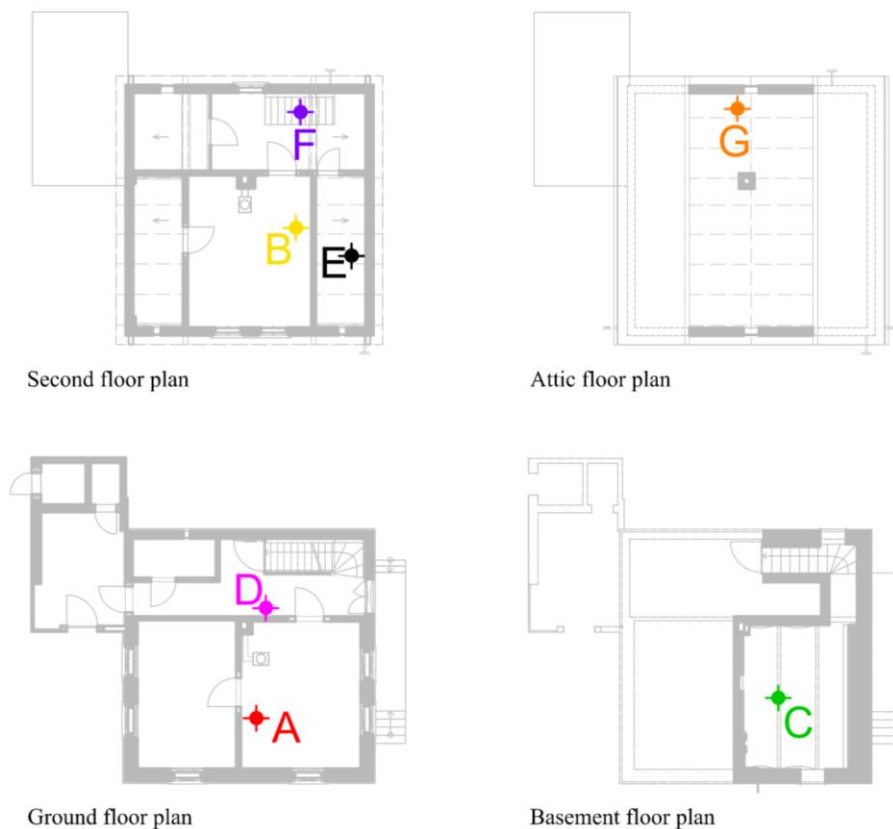
Fig. 2 The plans of the case study house with positions of dataloggers. Dataloggers U3430 were used in the living areas (A – living room, B – bedroom). Dataloggers U3120 were used in unoccupied rooms (C – basement, D – corridor on the ground floor, E – chamber under the roof, F – corridor on the second floor, G – attic, H – outside).

We used mobile dataloggers for the monitoring. We placed each datalogger in a different room in the case study building. The positions of dataloggers are presented in Fig. 2. The positioning of dataloggers was limited by the case study house being used by its inhabitants. The ideal positioning of dataloggers in the middle of the room at a height of 1 meter was not always achievable. We positioned the dataloggers as close to the ideal locations as possible without disturbing the residents.

We used six Comet U3120 dataloggers to monitor RH and air temperature and two Comet U3430 dataloggers to monitor RH, air temperature, and CO₂ concentration. The LCD displays of the dataloggers were turned off during monitoring so that the inhabitants did not influence the results by knowledge of the parameters. We collected the data from dataloggers after the monitoring was finished and evaluated the results in the Comet Vision Software. The calibration sheets of the data loggers indicate the following measurement uncertainties: temperature ± 0.4 °C, relative humidity ± 1.8 %, CO₂ concentration ± 50 ppm.

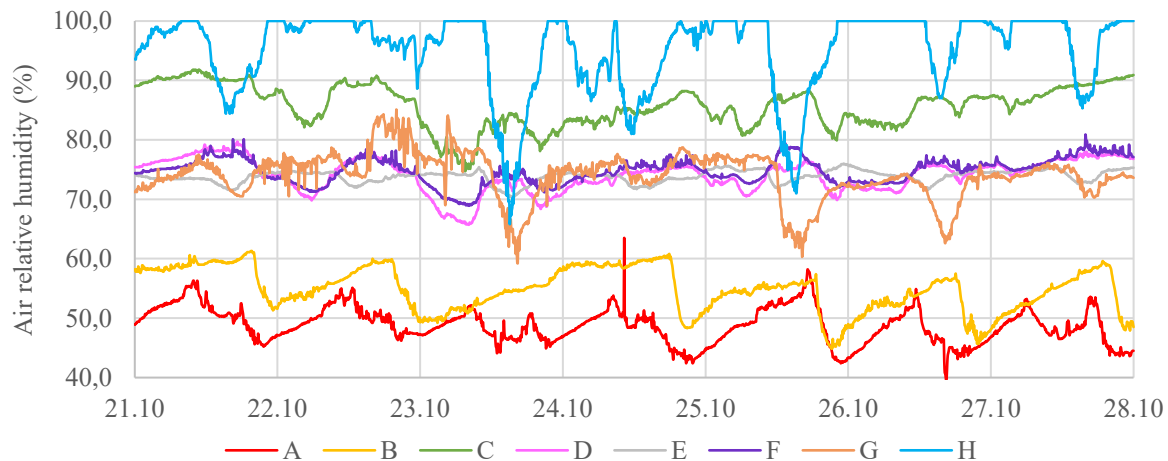
Fig. 6 The air relative humidity data from Monday 21/10/2024 0:00 to Monday 28/10/2024 0:00. Refer to Fig. 2 in the methodology section for the curve labels (A to H).

During the autumn period, the outdoor RH was high (H). It reached an average of 95.2%. In the morning and daytime, it reached a maximum saturation of 100%, which manifested itself as mist. The heating of the interior spaces (A – living room, B – bedroom) had the effect of lowering RH. In the living room (A), it reached an average of 48.8% and in the bedroom, it reached an average of 54.8%. Among the other unoccupied rooms, the highest RH was recorded in the basement where it reached an average of 85.8%. In the other unoccupied rooms, RH was recorded steady at around 74%.

in the living rooms (A, B) did not exceed the recommended threshold of 40% and 65% in the long term and shows good living conditions. (Fig. 5, Fig. 6, Tab. 2).
